“Implementation in real SOFC Systems of monitoring and diagnostic tools using signal analysis to increase their lifeTime”

Deliverable D2.5.

Faults/failures implemented on SRU/SS/Stack and EIS/THD techniques as a detection tool

Final report

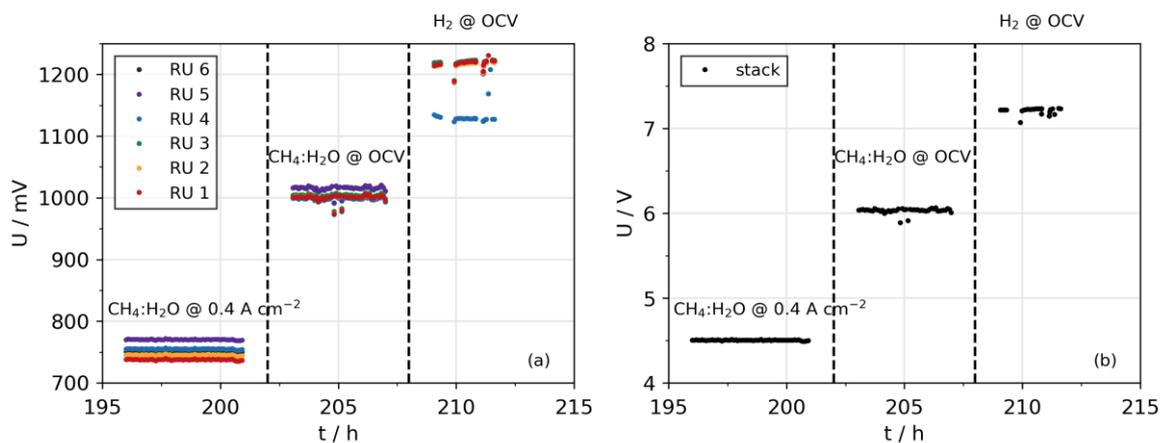
Fig. 1. Cell voltages of each RU (a) and stack voltage (b) at  $0.4 \text{ A cm}^{-2}$  operated with  $\text{CH}_4:\text{H}_2\text{O}$  1:2 fuel (first segment), at OCV with the same fuel gas composition (second segment) and at OCV with dry  $\text{H}_2$  fuel (third segment). For better visualization polarization measurements at each steps are excluded.

**Leakage - Fault detection via ‘conventional signals’.** Fig. 1 shows the stack voltage and the individual cell voltages of RU 1-6 under operation ( $j = 0.4 \text{ A cm}^{-2}$ ,  $\text{CH}_4:\text{H}_2\text{O}$  1:2, FU 77%), at OCV conditions in  $\text{CH}_4:\text{H}_2\text{O}$  1:2 fuel and dry  $\text{H}_2$  fuel. The cell voltage of RU4 clearly stays approx. 100 mV below the remaining RUs in the last segment (dry  $\text{H}_2$ ). In contrast, the stack voltage signal alone in dry  $\text{H}_2$  or operation under current and introduction of steam ( $\text{CH}_4:\text{H}_2\text{O}$  fuel) doesn’t allow distinguishing the leaky element. Therefore, the leakage fault only becomes obvious under dry fuel conditions at OCV and detection requires monitoring of individual cell voltages.

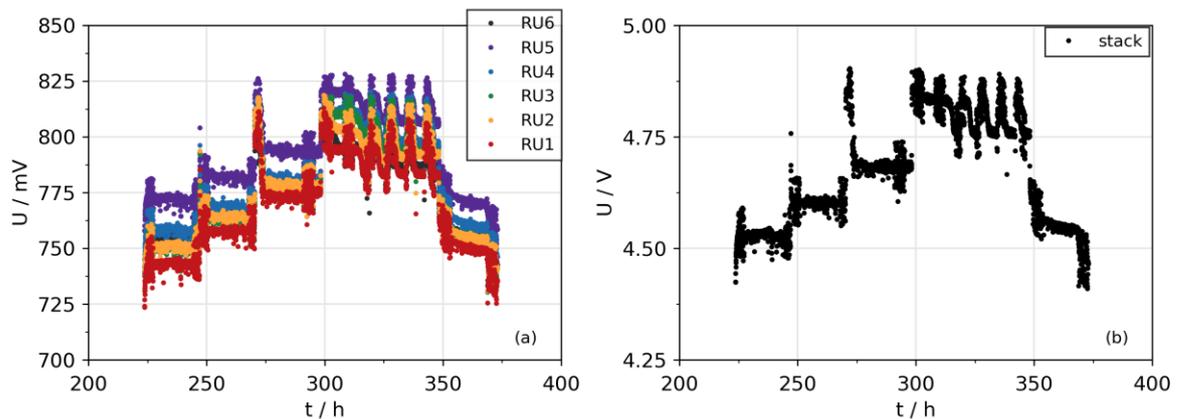
Fig. 2. Cell voltages of each RU (a) and stack voltage (b) monitored while decreasing the SC-ratio from 2 to 0.5 at  $0.4 \text{ A cm}^{-2}$ . For the final 24 h of the test, the stack was set back to the initial testing conditions.

**Carbon deposition I - Fault detection via ‘conventional signals’.** In Fig. 2 the voltage recording of each RU (a) and the total stack voltage (b) vs. time are displayed. The successive steam content reduction resulted in a nearly constant increase of the cell voltage between 15 – 20 mV per RU per step, whereas increasing the steam feed in the final sequence caused the cell voltage to level out close to the initial cell voltage at the beginning of the test. The observed operation signals are therefore suggesting non-detrimental operating conditions.

The noticeable fluctuations of the voltage signal are a result of the electrochemical impedance measurement at the initial and final part of each step. However, the nearly periodically fluctuations recorded at the SC ratio = 0.5 are most likely caused by an instability of the installed fuel gas pre-

heater in the testing station. With the change in gas compositions the fuel gas pre-heater temperature successively increased in a likewise manner. After trespassing an apparent threshold of ca. 400 °C these fluctuations could be seen in the cell voltage recording. However, at this stage, the occurring phenomenon is not yet understood and requires further investigation, but it could be caused by locally occurring carbon deposition in the pre-heater.

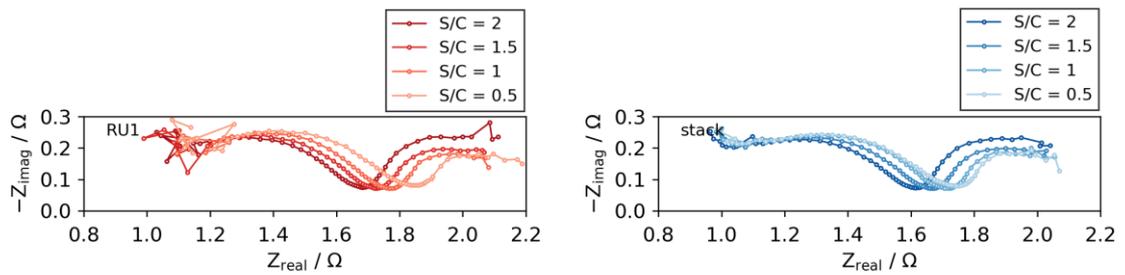
Fig. 3. IS of RU1 (left) and of the averaged RU from stack IS (right) at different SC ratio. The SC ratio was caused by decreasing the steam feed in the fuel. Please note that presented EIS data is including artefacts of the testing station. Nevertheless, the EIS data allowed fault metric identification.

Aside from voltage and temperature measurements, EIS was performed. Recorded Impedance Spectra (IS) at each SC reduction step are presented in Fig. 3. The averaged RU IS (i.e. recorded stack IS/number of RU) and of the first RU1 show similar trends. With each decrease in steam feed, an increase of the semi-circle in the high frequency region occurs and is accompanied by an opposite

trend of the low frequency region arc. Regarding the serial resistance, no or only minimal changes are detected.

These changes clearly reflect the fuel gas composition changes varied at each step, yet the ‘0.5 SC-ratio step’ (also recorded over time) did not change considerably and no carbon formation became apparent. Yet, the observed IS pattern can be used as a preliminary fault signal, indicating an atypical gas composition. Moreover, recording of solely the stack impedance enables detection.

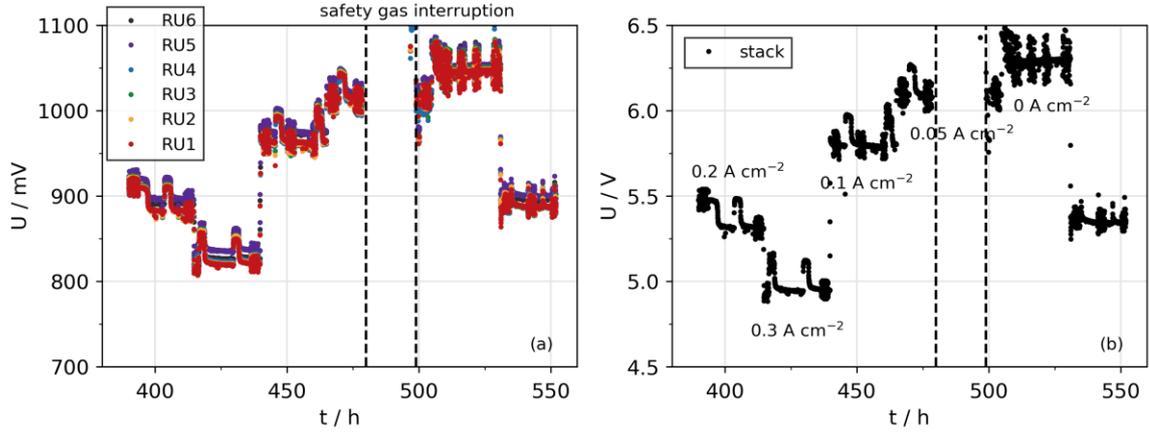
Fig. 4. Cell voltages of each RU (a) and stack voltage (b) monitored while decreasing the current density from 0.3 to 0 A cm<sup>-2</sup> at SC=1. For the final 24 h of the test, the stack was set to  $j=0.2$  A cm<sup>-2</sup>. An interruption of the test at 480-499 h was caused due to a precaution system of the testing station, setting the stack to OCV in forming gas.

**Carbon deposition II - Fault detection via ‘conventional signals’.** After no obvious detrimental issue/fault was detected while conducting the ‘carbon deposition I’ experiment’, another fault investigation experiment on the same stack was performed. In Fig. 4 measurements of cell voltages of each RU and stack at different current densities in a  $\text{CH}_4:\text{H}_2\text{O}$  1:1 fuel are presented. Likewise to the carbon deposition I experiment, a decrease in operating current caused an increase in cell voltage. For the explanatory chosen RU1 each  $0.1 \text{ A cm}^{-2}$  step caused a voltage increase of approx. 66 to 79 to 85 mV – indicating a non linear increase of cell voltage current dependency. Similar to the fluctuation discussed in the ‘carbon deposition I’ experiment, the pre-heater influence can also be seen here. After identifying this correlation, the pre-heater temperature was deliberately reduced below  $400^\circ\text{C}$  and therefore the fluctuations are not occurring in the last two steps.

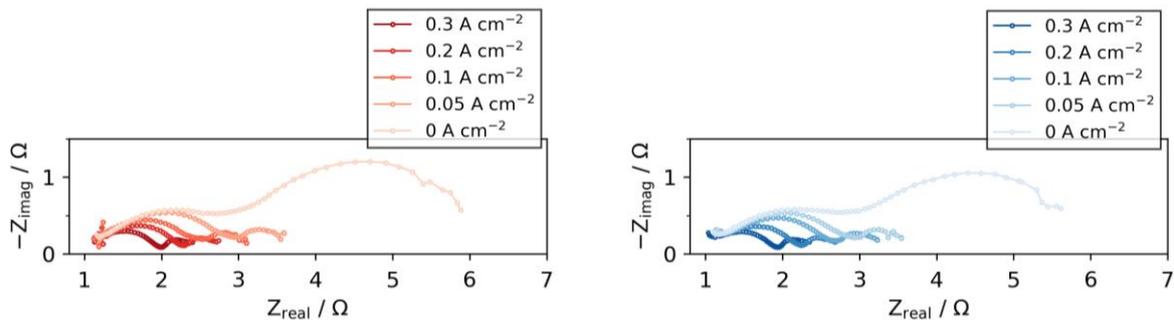
Fig. 5. IS of RU1 (left) and of the averaged RU from stack IS (right) at different current densities. Please note that presented EIS data is including artefacts of the testing station. A testing station impedance will be recorded to subtract and account for the testing station impedance. Nevertheless, the EIS data allowed fault metric identification.

**Fault detection via EIS.** Each step was furthermore monitored by EIS over time. The resulting IS at each ‘current-reduction step’ are given in Fig. 5. Primarily, the resistance of the semi-circle at high frequencies shows a stepwise increase with a co-occurring slide increase of the low-frequency semi-

circle. Yet, at OCV(‘zero-current step’) the low-frequency arc expands tremendously, thus being an obvious metric for reaching the most critical conditions.

In summary however, EIS over time at each step did not indicate any significant change, so no sign for any destructive stack/cell failure could be extracted. The IS metric are therefore only monitoring the change of conditions, showing that the stack is now operating under unsafe conditions. Similarly to the carbon deposition I experiment, the metrics can be extracted solely from a stack impedance measurement and do not necessitate the implementation of single RU measurements.

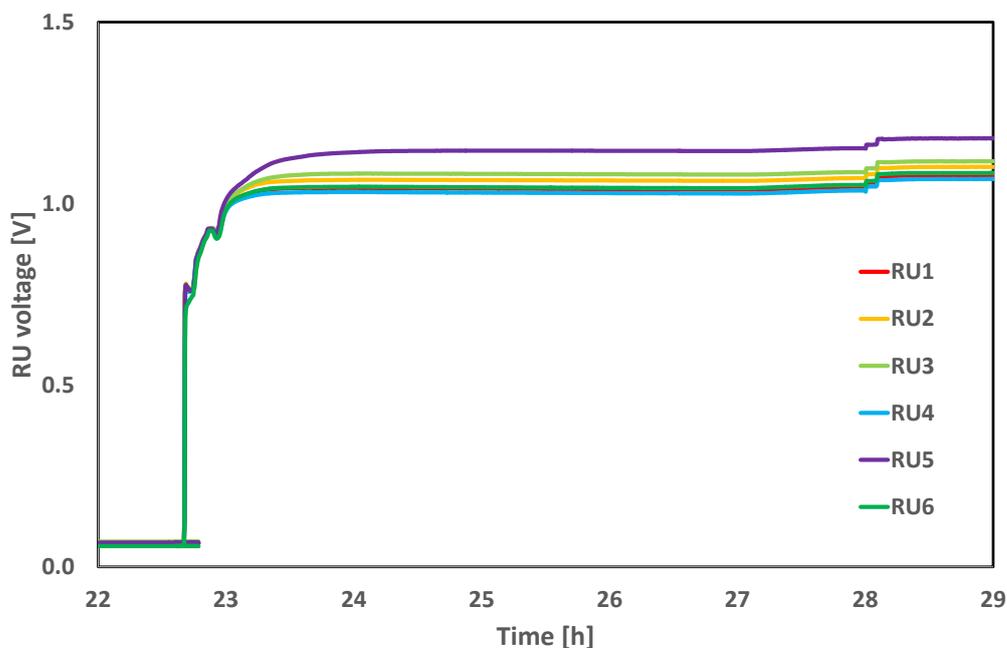
Fig. 6. Evolution of RU voltages during reduction.

First, the individual RU voltage evolution has been acquired for each of the six cells (cf. Fig 6). There is nothing particular to report except that all voltages stabilized around 1.1 V, which is lower than what was reported for the other short-stacks. Only RU5 is higher than the rest, with 1.18 V. The lowest OCV is that of RU4, but the differences remain slight.

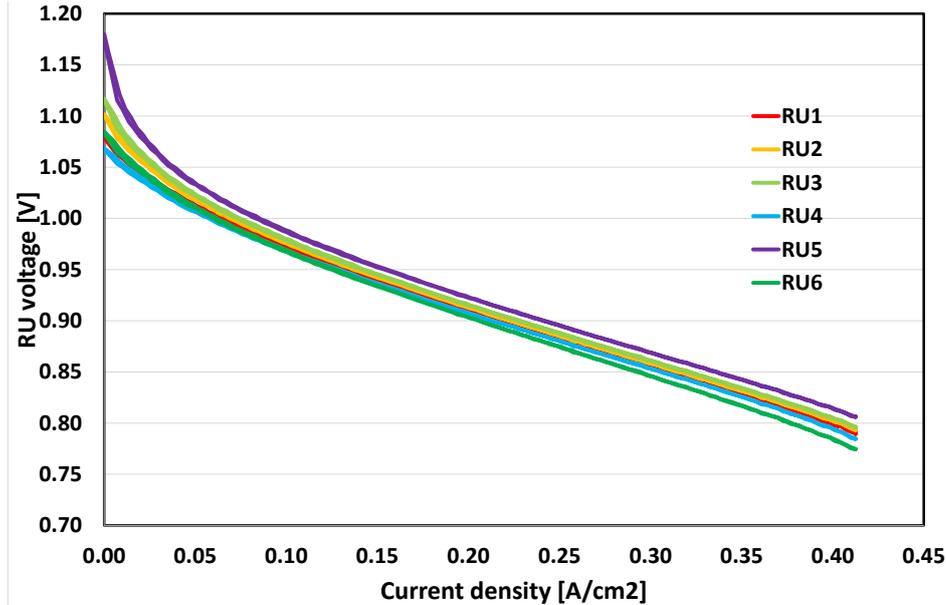
Fig. 7.  $i$ - $U$  characterization of 6RU short stack with a defective sealing at the inlet in RU4 (conditions:  $750^{\circ}\text{C}$ , air:  $32 \text{ NL}/\text{min}$ ).

The initial  $i$ - $U$  characterization is shown in Fig. 7. As stated above, RU4 has the lowest OCV but under polarisation it is RU6 that shows the lowest voltage at  $0.4 \text{ A}\cdot\text{cm}^{-2}$ . As RU6 is the top RU located the furthest from the fuel inlet, it is expected that this RU sees less fuel in case of leakage in the stack and would therefore experience fuel shortage at high fuel utilization. However, RU5, which is the direct neighbour of RU4, shows the best performance. This strange behaviour could be explained by the fact that the leakage in RU4 produces locally extra steam that increases the pressure drop in the RU4, which results in a redistribution of part of the fuel among the neighbouring RUs 3 and 5. The  $i$ - $U$  characteristic is quite different from that of the previous case, where the leakage was located close to the outlet. The leakage close to the inlet impacts more severely the OCV of not only the defective RU but also of the neighbouring RUs, indicating that it can more easily be identified during the qualification test of the full stack.

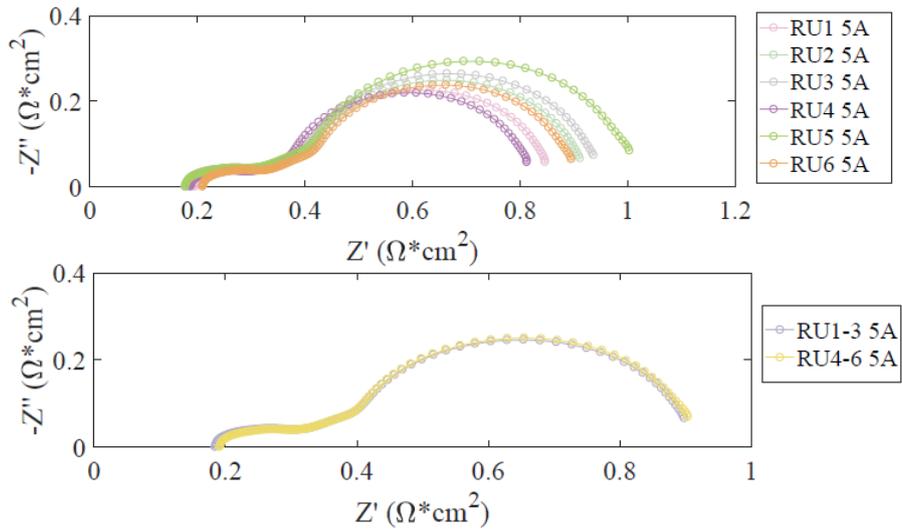
Fig. 8. Nyquist plot of the EIS data measured on a 6-RU short-stack with a defective sealing at the inlet of RU4: (top) individual RU; (bottom) clusters 1-3 and 4-6.

Fig. 8. shows the EIS spectra as Nyquist plots for both the individual RUs (top) and 3RU clusters (bottom). As the EIS measurement was performed at low current density bias ( $0.0625 \text{ A}/\text{cm}^2$ ), the defective RU (RU4) has a smaller polarization resistance due to a higher steam content resulting from the leakage. As for the  $i$ - $U$  measurement, the defective element can clearly be identified at the single RU level contrarily to the case where the defective sealing is located close to the outlet. However, at the cluster level, this information is lost through averaging. This can be clearly seen in Fig.8 (bottom) by comparing clusters RU1-3 and RU4-6.

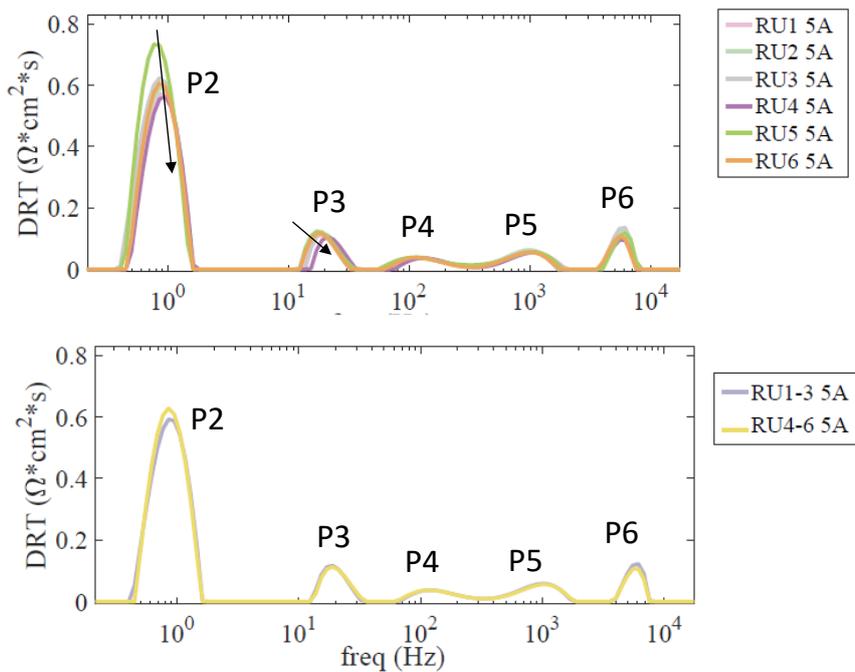
Fig. 9. DRT of the EIS data shown in Fig. 8.

The EIS data was further analyzed by performing DRT. The results are shown in Fig. 9.

In line with the observation made for Fig. 8, it appears that it is peak P2 that contributes most to the reduction of the polarization resistance of R4 under these operating conditions. As mentioned above, this relates to the steam content which reduces the conversion impedance. Peak P3 is also affected by a shift towards higher frequencies. Nevertheless, this information is lost through averaging, even in the case of 3 RUs.

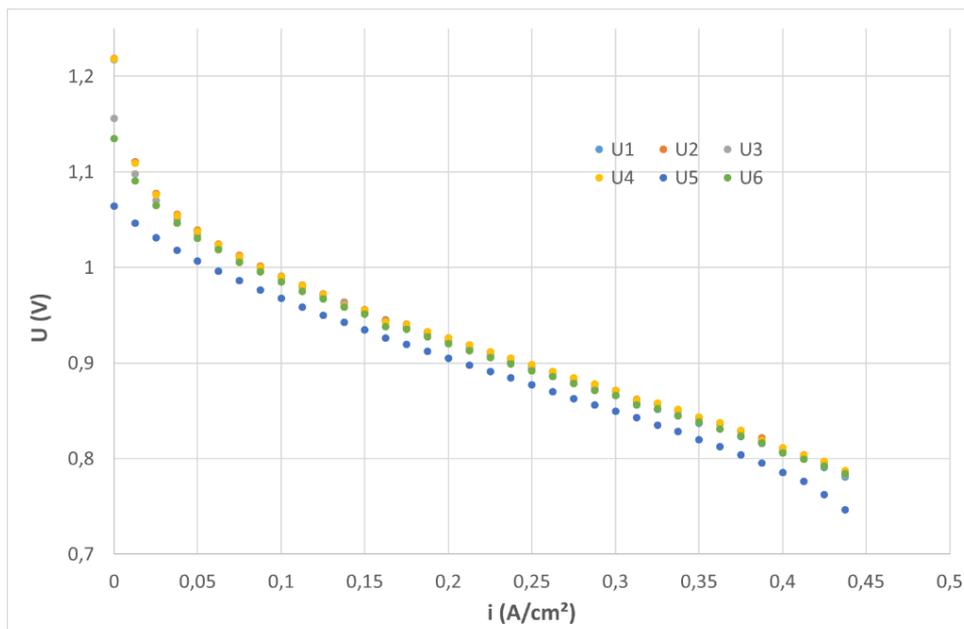
Fig. 10. *i-U* characterization of 6RU short stack with a defective sealing at the outlet in RU3 (conditions: 750°C, H<sub>2</sub>/N<sub>2</sub>=3.6/2.4 NmL/min/cm<sup>2</sup>, air=66.7 NmL/min/cm<sup>2</sup>).

From iV curves under nominal operating conditions (see Fig. 10), the lowest performance is obtained with RU5 (lowest OCV) but it is difficult to say for others RUs.

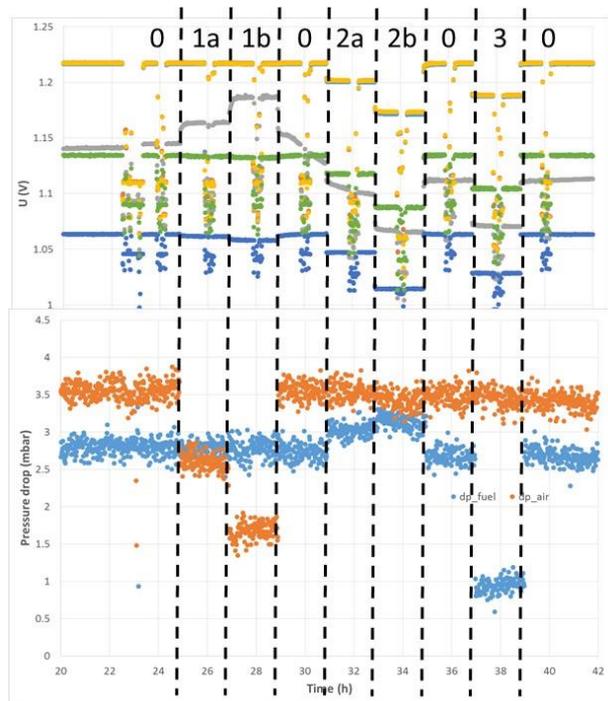
Fig. 11. Evolution of OCV (top) and of pressure drop (bottom) during the testing sequence of Table 2.

It has been found that when air flow rate decreased, OCV of RU3 increases and OCV of RU5 slightly decreases, other cells are constant. When the H<sub>2</sub>/N<sub>2</sub> ratio decreases, all OCVs decrease. When total fuel flow rate decreases at H<sub>2</sub>/N<sub>2</sub> constant, all OCVs decrease. The pressure drop measurements tend to show that OCV of RU3 is clearly affected by pressure drop inside fuel/air side, as can be seen on Figure 11. Therefore it can be concluded that for this type of defect, some deviation trials as compared to the nominal operating conditions might be needed to highlight the issue, and the use of convention signals is meaningful.

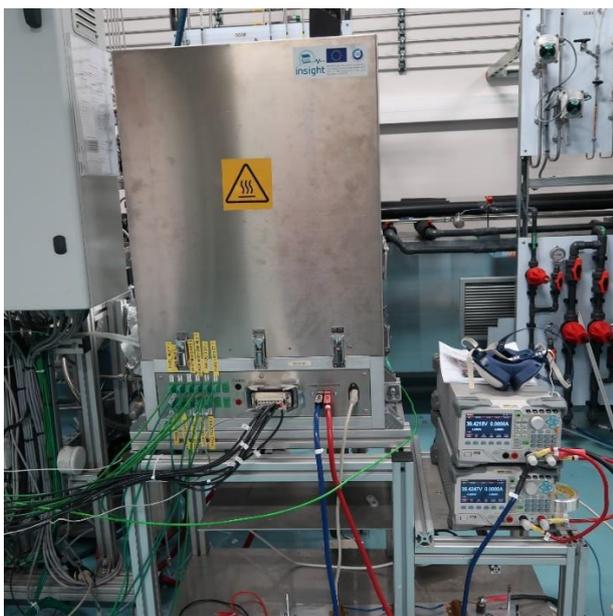
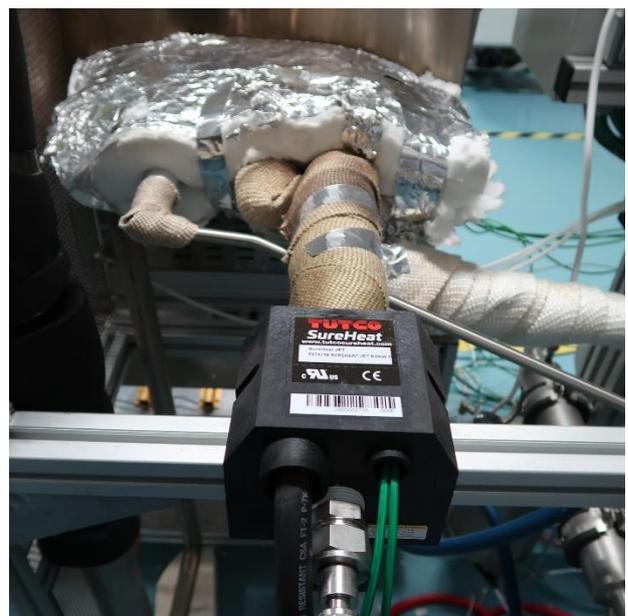
Fig. 12. (a) SOLIDpower 32-cells Stackbox implemented on CEA testbench and tested in collaboration with IJS. (b) Air preheater of 8 kW able to reach 700°C with an air inlet flowrate of 10 Nm<sup>3</sup>/h.

Figure 12 illustrates the environment of the Stackbox and the table 3 gives the detailed instrumentation implemented on this Stackbox.

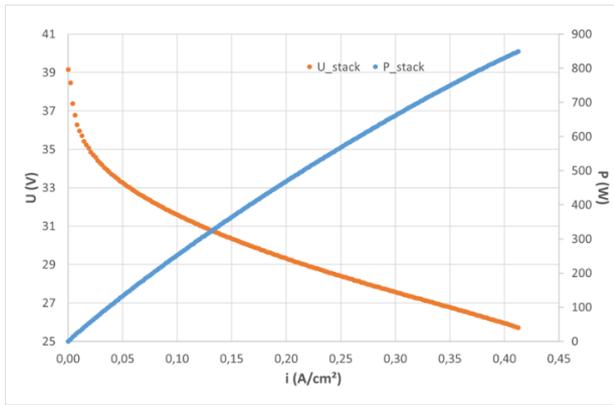
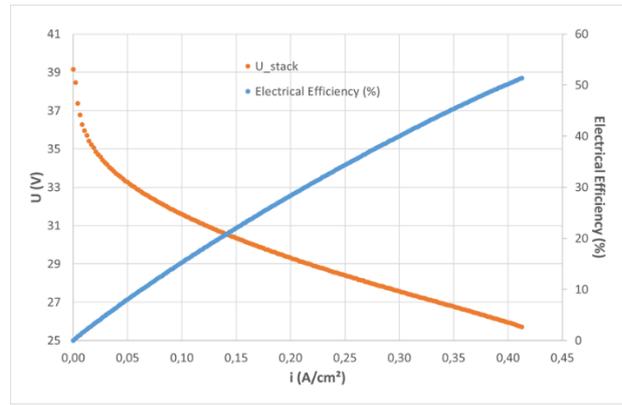
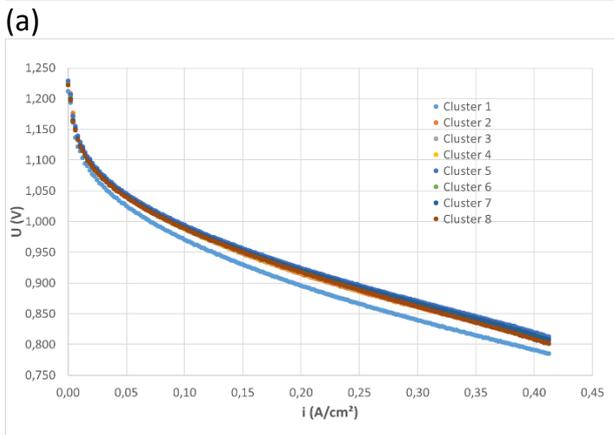
(b) Fig. 13. Performance achieved on SOLIDpower 32-cells Stackbox at  $T_{Air\_Outlet}=720^{\circ}C$ , in nominal operating conditions:  $H_2/N_2=3.6/2.4$  NmL/min/cm<sup>2</sup>, air=66.7 NmL/min/cm<sup>2</sup>. (a) Stack voltage and Stack Power during i-V characterization, (b) Electrical efficiency during i-V characterization and (c) Voltage of the 8 clusters during i-V characterization.

I-V curve has been measured on the stackbox. Figure 13a represents the stack voltage and the stack power as a function of current density. Figure 13b represents the electrical efficiency as a function of the current density and figure 13c the voltage of the 8 clusters during i-V characterization. At i=33 A (0.413 A/cm<sup>2</sup>), a fuel utilization FU=0.8, a power P=848 W and an electrical efficiency η=51,3% are achieved. These values are close to those achieved by SOLIDpower before the delivery of the Stackbox. From iV curves under nominal operating conditions (see Fig. 13c), the lowest performance is obtained with Cluster1 (lowest OCV).

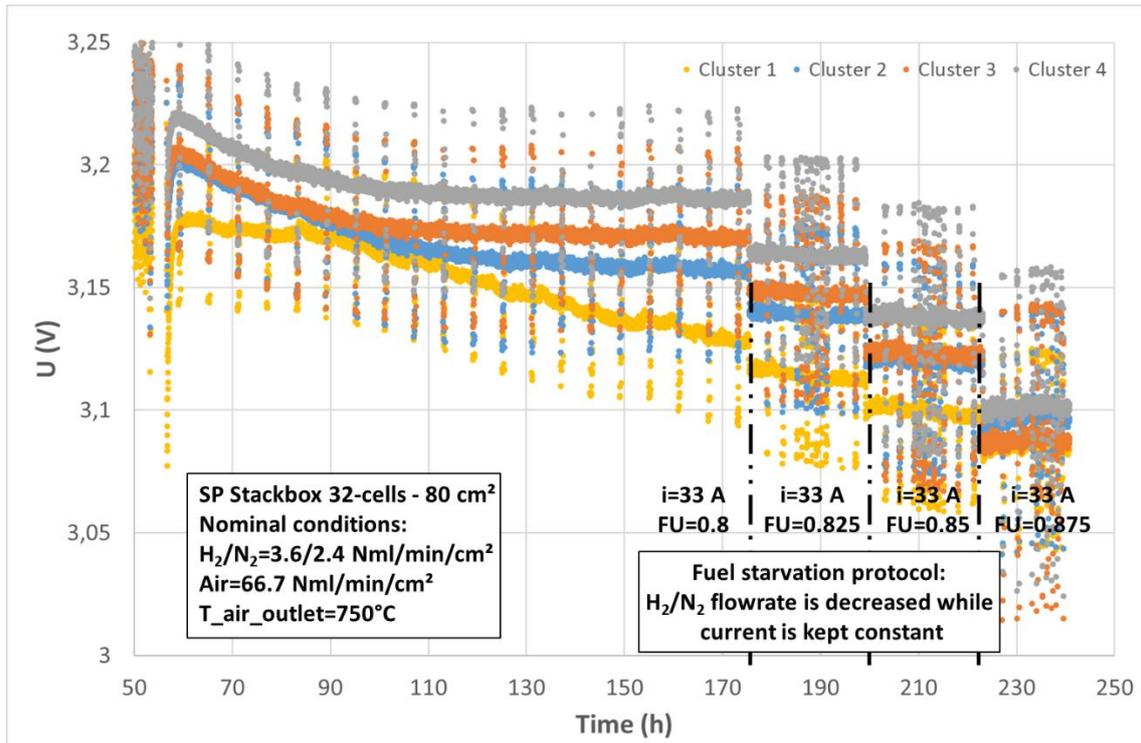
Fig. 14. First part of the fuel starvation protocol on SOLIDpower 32-cells Stackbox.  $H_2/N_2$  flowrate is decreased while current is kept constant at 33 A.  $T_{Air\_Outlet}=750^\circ C$ .

Figure 14 shows what has been achieved so far under polarization of the Stackbox. First, more than 170 h in nominal operating conditions and  $i=33$  A ( $FU=0.8$ ), then by applying the fuel starvation protocol, i.e.  $FU$  is increased from 0.8 to 0.875 by decreasing  $H_2/N_2$  flowrate while current is kept constant at 33 A (summarized in Table 5). EIS/PRBS excitations are implemented by IJS every 6 h at  $FU=0.8$  and at least every 3 h during steps of 24 h at higher  $FU$ . PRBS excitation presents the advantage to be faster than sine excitation in these testing conditions. The objective is to see if we are able to detect the signature of fuel starvation at the cluster level despite the averaging.

Cluster voltage measurements are relatively close during the first 170 h at  $FU=0.8$  even if fluctuations can be seen due to probably thermal stabilization of the stackbox. When  $FU$  is increased to 0.825, 0.85 and finally 0.875, all cluster voltages are gathering. It seems that only at  $FU=0.875$ , we can detect some distortion of the signal when EIS/PRBS excitation is superimposed, especially on clusters 3 and 4. It means that we are probably in the non-linear part of the i-V curve and we will get higher THD index. A complete data analysis is needed to confirm this trend.

EIS/PRBS excitations are implemented by IJS every 6 h at  $FU=0.8$  and at least every 3 h during steps of 24 h at higher  $FU$ . Note: only 4 clusters are represented here, the 4 others having a similar response.

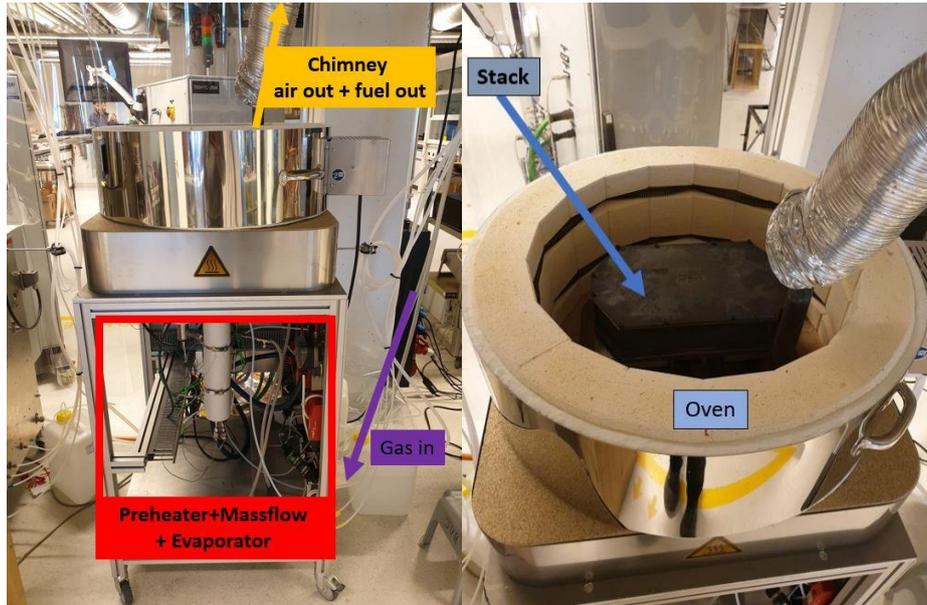
Fig. 15: EPFL SOFC test rig for short stacks. On the left a 6 cell SolidPower short stack inside the furnace.

The tests set-up consisted of the EPFL stack tester Fig. 15 and the AVL e-Gen Spectrolyzer Fig. 16.

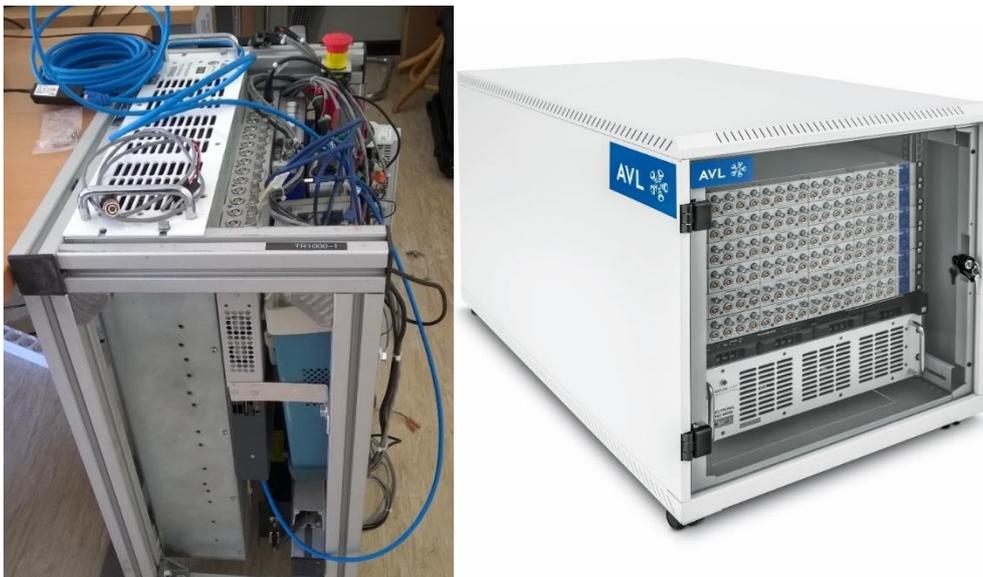
Fig. 16: Two versions of the e-Gen Spectrolyzer, on the left version 1 with one X-Ion base unit (used during the test campaign at EPFL) and on the right version 2 in a commercial 19"-rack (fully equipped with 6 cascaded X-ION and 64 channels, max is 196 channels in parallel).

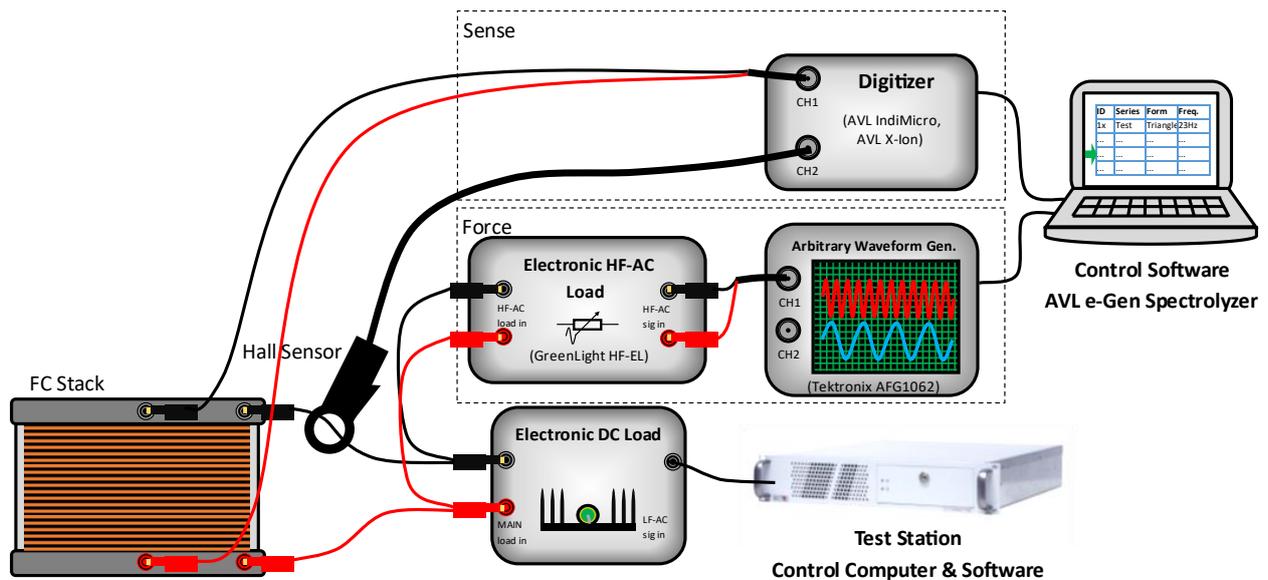
Fig. 17: e-Gen Spectrolyzer configuration at EPFL. Sampling rate of the digitizer AVL X-ION up to 2.0 MHz on multiple channels in parallel. Perturbation unit is a Greenlight Innovation load bank with a dynamic of up to 20 kHz and a max amplitude of 8.0 A.

The e-Gen Spectrolyzer is an assembly that is constituted of two main components: a perturbation unit and data acquisition HW (DAQ / digitizer), the complete topology is displayed in Fig. 17.

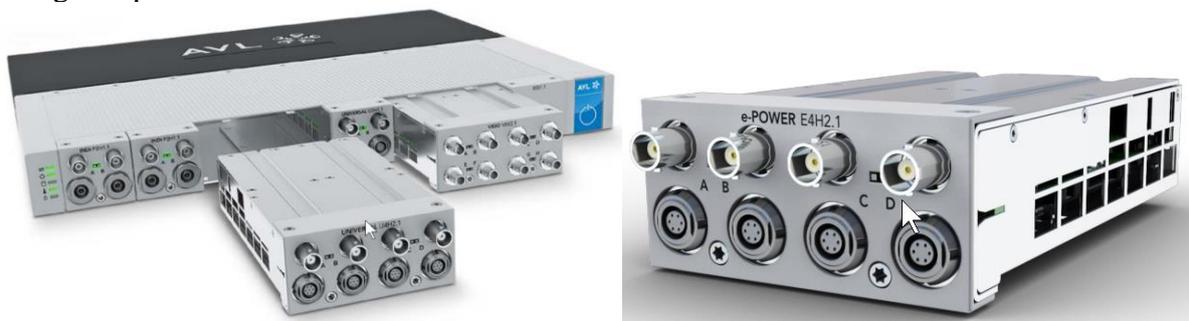
Fig. 18: X-ION Base unit, equipped with different front-end modules (FEM / X-FEM). On the right an e-Power X-FEM with 4 channels. Resolution 18 bit. Voltage range +/- 60 V. Measurement bandwidth 2 MHz.

The digitizer consists of the base unit AVL X-ION and multiple front-end modules of type “e-POWER E4H2.1”, each module can record four channels. In the setup at the EPFL 4 of these modules had been installed. The current sensor is a so called Zero-Flux or No-Flux sensor; the advantages are high precision, hardly any hysteresis and a bandwidth up to 150.0 kHz, the sensor has an voltage output of -10 to +10V.

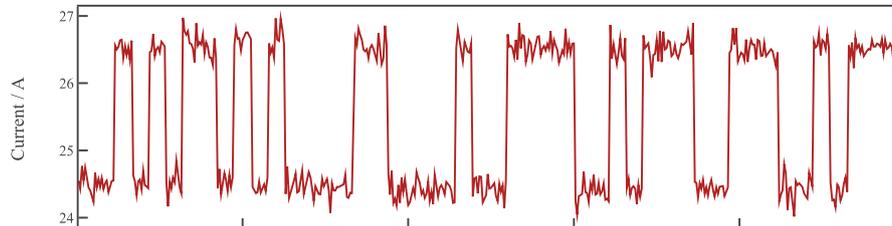
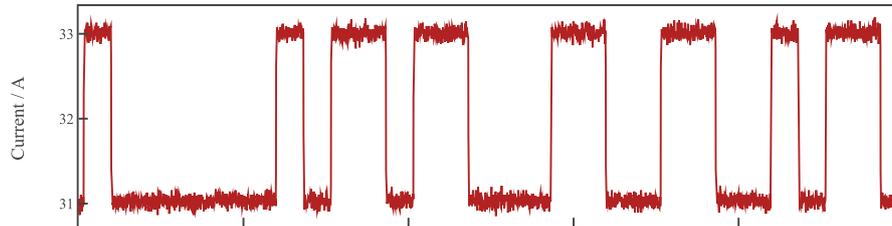
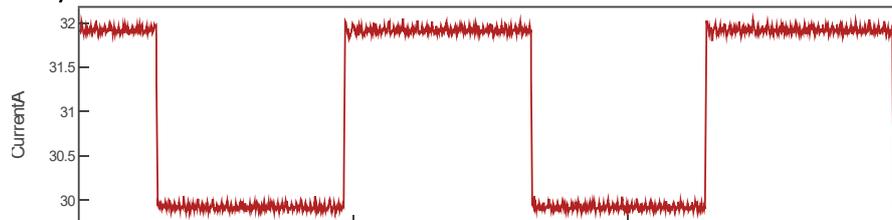
a) MDLT with a shunt resistor:

b) IJS vers1-HW with standard HALL sensor:

c) e-Gen Spectrolyzer with Zero-Flux sensor:

Fig. 19: Comparison of three DAQ-devices: a) MDLT (Monitoring, Diagnostic and Lifetime Tool), b) IJS vers1-HW, c) AVL e-Gen Spectrolyzer.

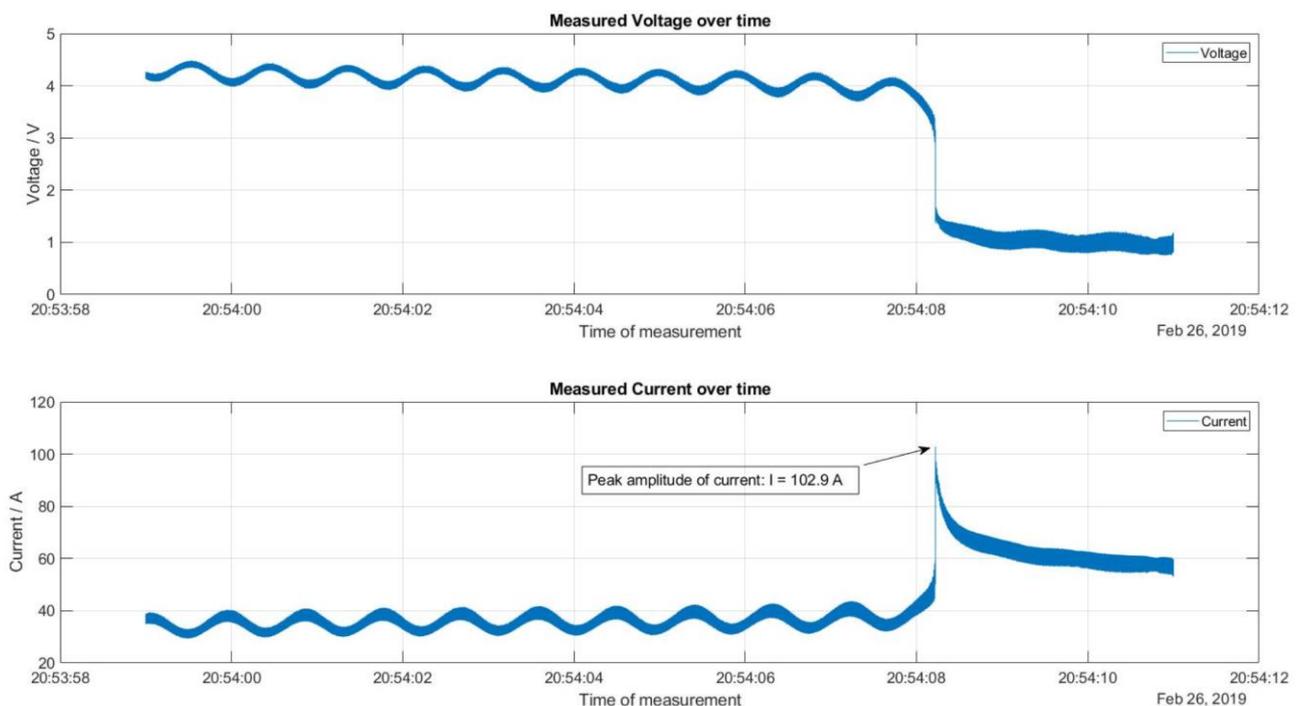
Fig. 20: Incident that led to the ruin of UUT4. We can observe a slight decrease of voltage which let to the test station rapidly increasing the current.

Beside the constant current mode also a constant power mode had been added to the test regime as described in the standard test protocol provided by the partner DTU. In combination with a missing voltage threshold to limit the DC-current a problem occurred while testing under constant power mode. Due to constant power mode the test station kept increasing the current to compensate for the decrease of voltage. As the test station had no limits implemented for maximum current drawn it peaked out at 102.8 A, as can be seen in Fig. 20. This destroyed the stack. Especially RU 3 was damaged badly, which made further testing on UUT4 impossible.

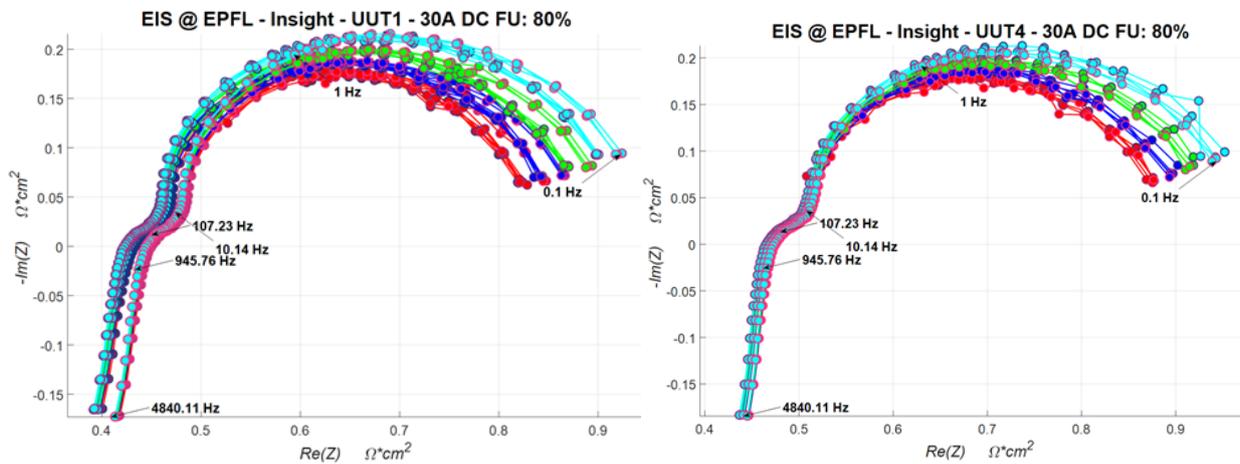
Fig. 21: EIS on UUT1 (left) and UUT2 (right) with the same fuel utilization (FU) and the same DC current BIAS of 30 A. The different colours represent different amplitudes of excitation currents: red 0.5 A, blue 1.0 A, green: 1.5 A, light blue: 2.0 A.

To figure out which excitation current is suitable to measure impedance spectra the current amplitude had been varied in four steps from 0.5 up to 2.0 A, which is equivalent to a current density range from 6.25 to 25.0 mA/cm<sup>2</sup>. To fulfil the requirement of linearity between perturbation and response, impedance values for one frequency must be the same for the excitation range that is inside the linear domain. As shown in Fig. 21 the impedances for the same frequencies show a sensitivity on the excitation amplitude, which indicates a non-linear behaviour of the voltage response. Therefore, the lowest imposed amplitude of 0.5 A is the most appropriate choice in this range. This is an unexpected result, as it was anticipated that 1.0 A should be feasible at a current DC BIAS of 30.0 A.

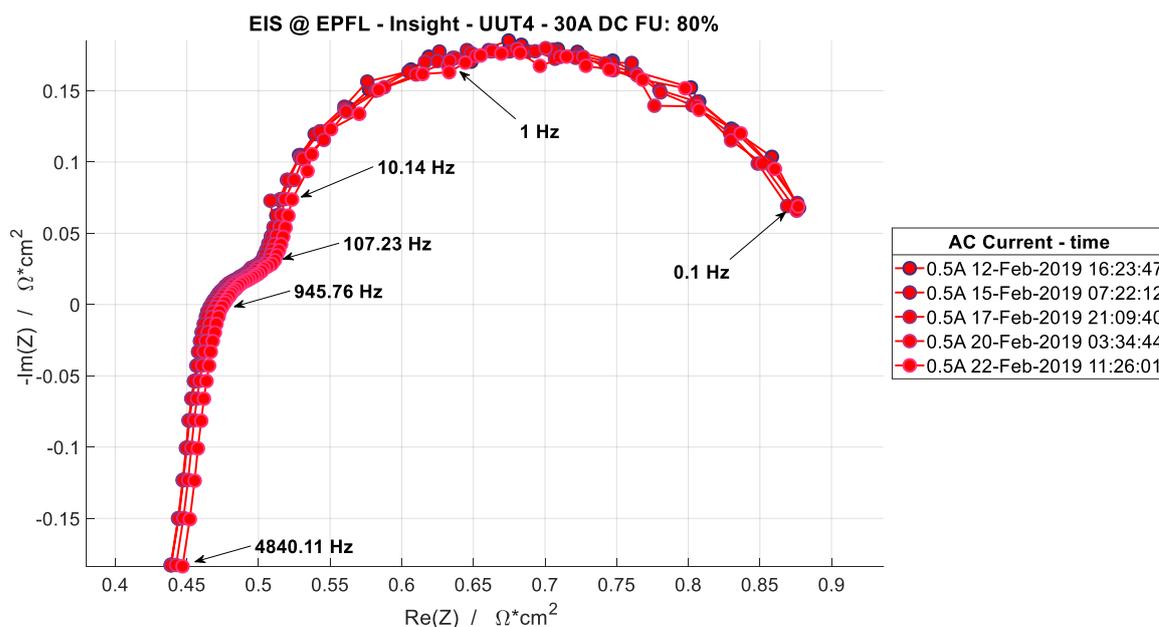
Fig. 22: EIS tests performed on UUT4. Cell area: 80 cm<sup>2</sup>.

The difference in impedance between the distinct AC excitation currents at lower frequencies indicates a nonlinear behaviour of the stack at set stoichiometry. This is rather odd because the used excitation current was well under 10% of the set DC current of 30A. A possible explanation might be that the extremely low frequencies (0.1 ... 1 Hz) over or under supply the stack with hydrogen. As seen in Fig. 22. The impedance spectra get more similar the higher the frequency of the imposed current.

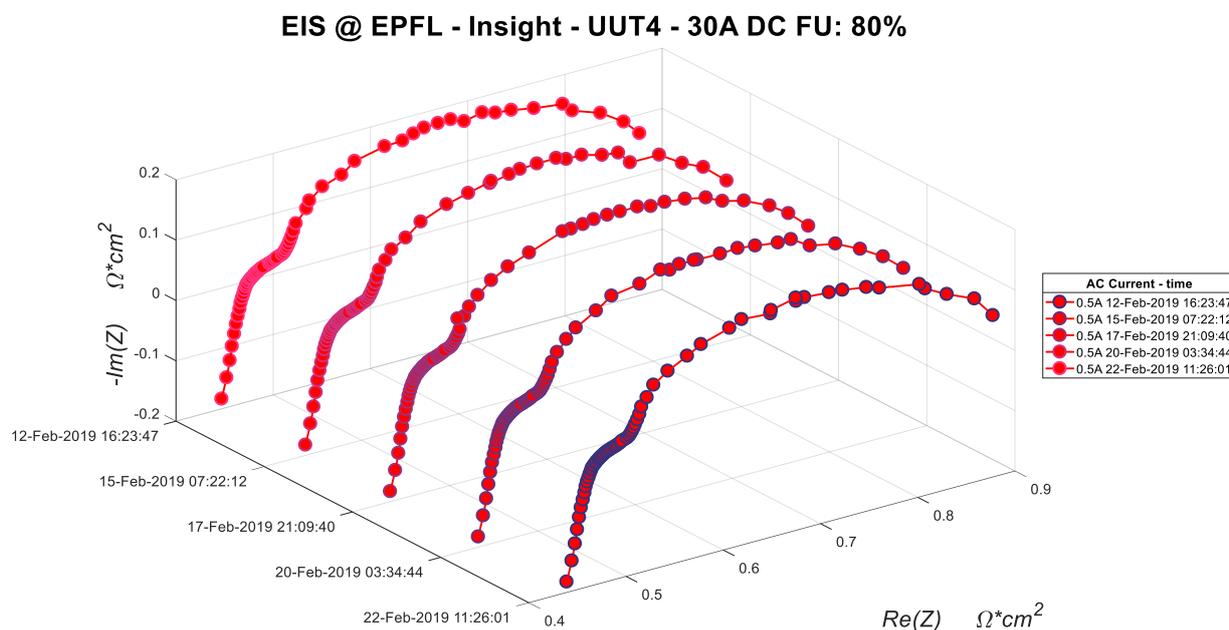
Fig. 23: EIS tests performed on UUT4, cell area: 80 cm<sup>2</sup>.

As seen in Fig. 23. There is no significant change in impedance spectra over the test period. This can be explained by the shorter test period due to the incident that happened while testing in constant power mode.

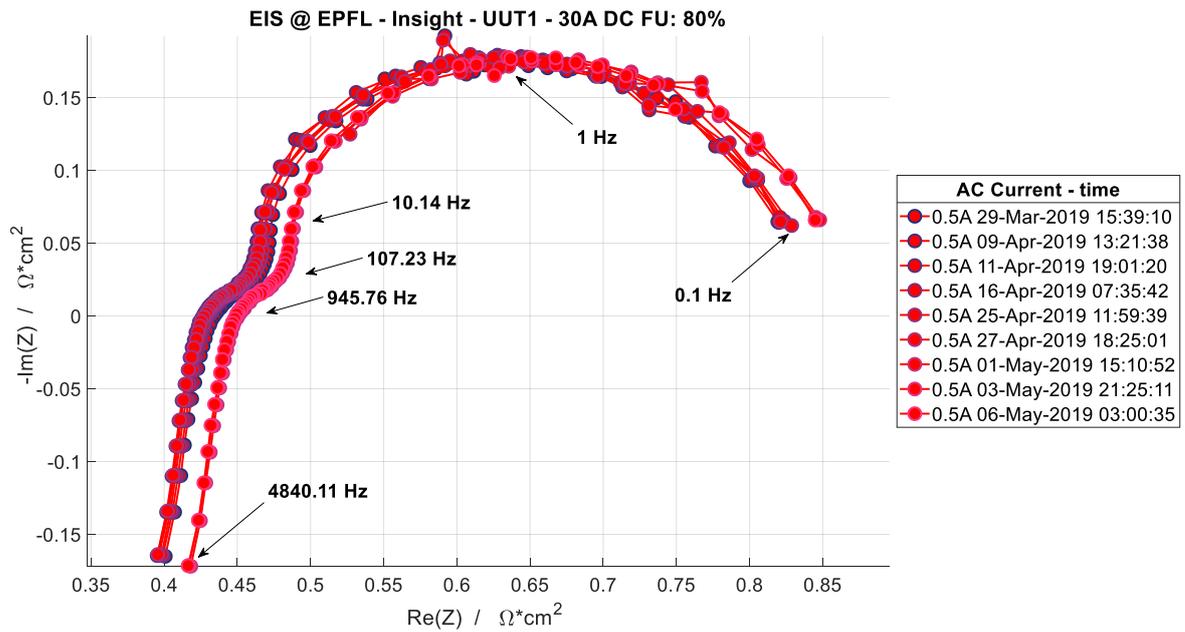
Fig. 24: EIS tests performed on UUT1. The difference in impedance is seen at higher frequencies. Cell area: 80 cm<sup>2</sup>

the root cause for this sudden degradation, but no fluctuation of media flows or temperatures could be observed during the period of rapid degradation.

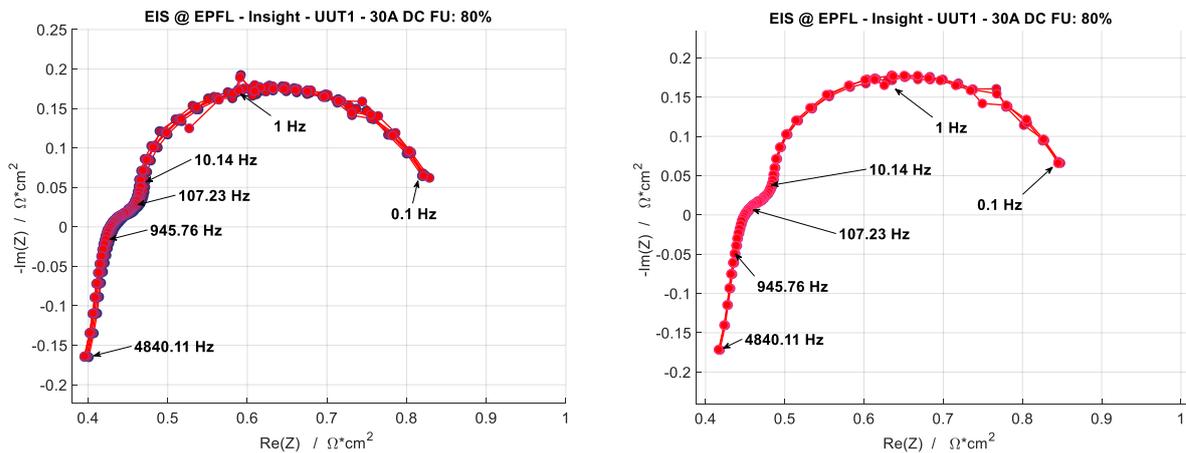
Fig. 25: Before (left) and after (right) the 27<sup>th</sup> of April. The stack degraded in a short period of time.

To have a more detailed view the two groups of EIS (“before” and “after”) have been plotted in Fig. 25 in separate graphs. It becomes clear that in the group “after” no further degradation is noticeable.

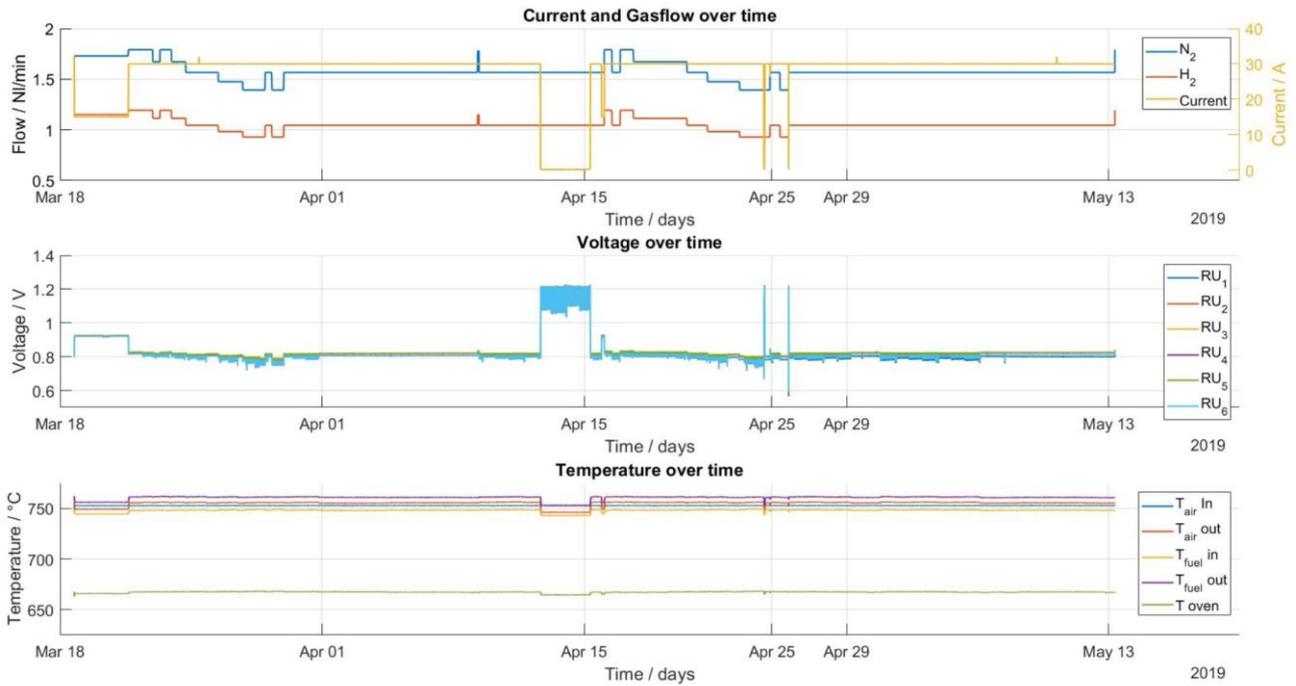
Fig. 26: Current, gas-flow, cell-voltages and temperature of the stack over whole test duration.

The change in H<sub>2</sub> and N<sub>2</sub> flows of the stack can be seen in Fig. 26.

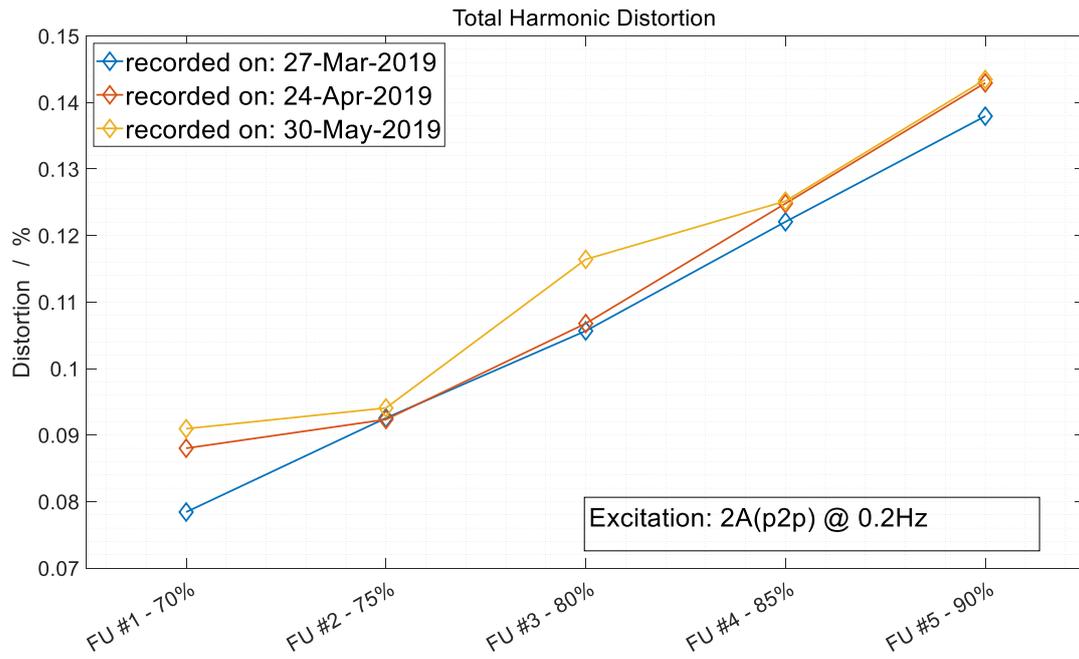
Fig. 27: THD over fuel utilization for UUT1 over whole test duration.

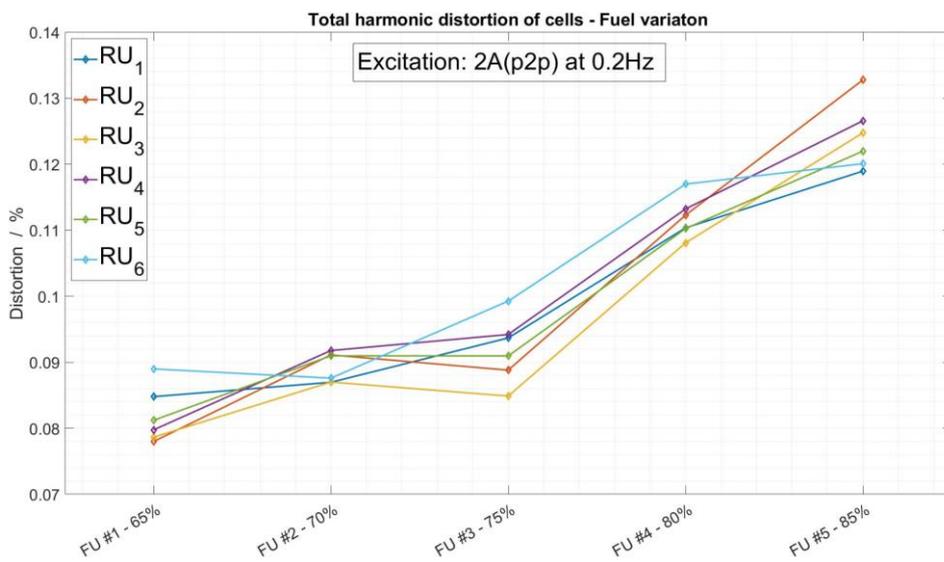
Fig. 28: THD over fuel utilization for UUT1 on repeating unit level.
