“Implementation in real SOFC Systems of monitoring and diagnostic tools using signal analysis to increase their lifeTime”

Deliverable D2.5.

Faults/failures implemented on SRU/SS/Stack and EIS/THD techniques as a detection tool

Final report

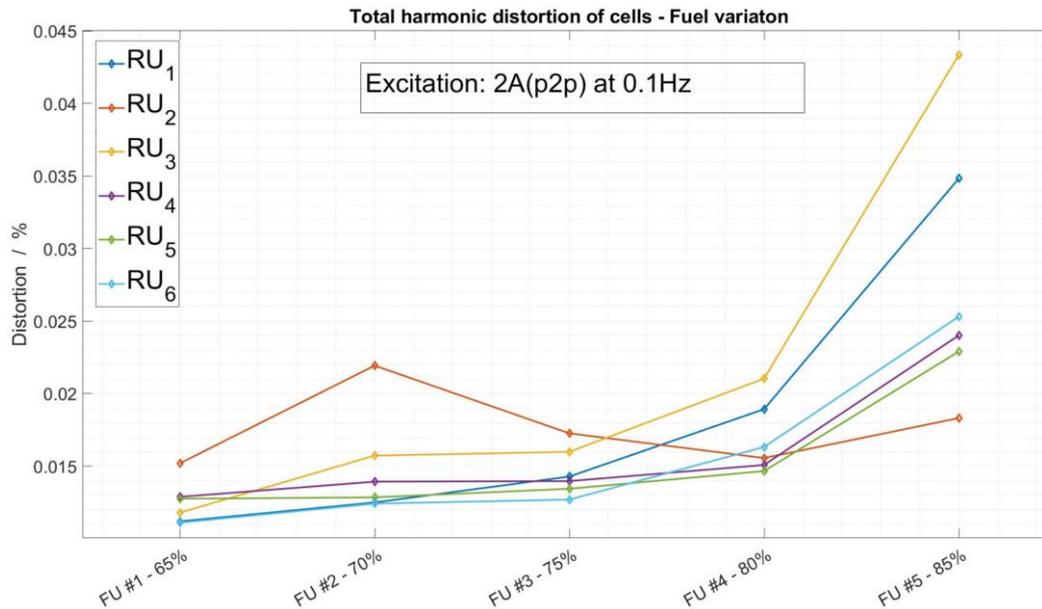
Fig. 29: THD over fuel utilization for UUT4 on repeating unit level.
