# Explosion free in fire self-venting (TPRD-less) composite tanks: Performance during fire intervention

V. Molkov, S. Kashkarov\*, D. Makarov

Hydrogen Safety Engineering and Research Centre (HySAFER), Ulster University, Jordanstown, Newtownabbey, BT37 0NL, Northern Ireland, UK

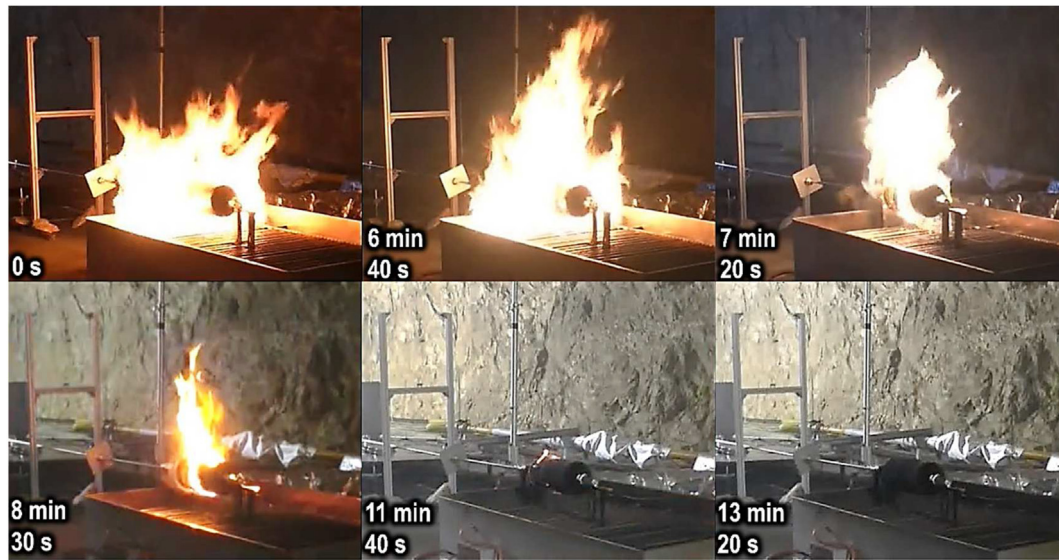
Fig. 5 – Snapshots of the  $\mu$ LNB tank fire test with COPV#CB-1.

Fig. 5 shows a series of snapshots of fire test with COPV#CB-1 prototype. The test starts when the burner is ignited (snapshot “0 s”). Microleaks are started after the liner melting at 6 min 40 s (snapshot “6 min 40 s”). The flame size around the tank is the same with insignificant increase at the moment of leak start. Snapshot “7 min 20 s” shows combustion of resin of the tank when the burner is switched off. What is seen in this snapshot is the combustion of composite resin assisted by hydrogen released through the microchannels in the wall. This hydrogen-assisted resin combustion is seen almost a minute after, in snapshot “8 min 30 s”, where the flames got smaller. Few residual flames only are seen in snapshot “11 min 40 s” that corresponds to the time when pressure drop stops due to the contraction of the composite wall at significantly decreased pressure and formation of the pressure plateau at level of 4.3 MPa, as well as freezing of melted before liner. No flame observed at snapshot “13 min 20 s”.
